COMPOSITE JOIST PROJECT

SPONSORED BY STEEL JOIST INSTITUTE

INTERPRETATION OF COMPOSITE JOIST TEST RESULTS

September 1967

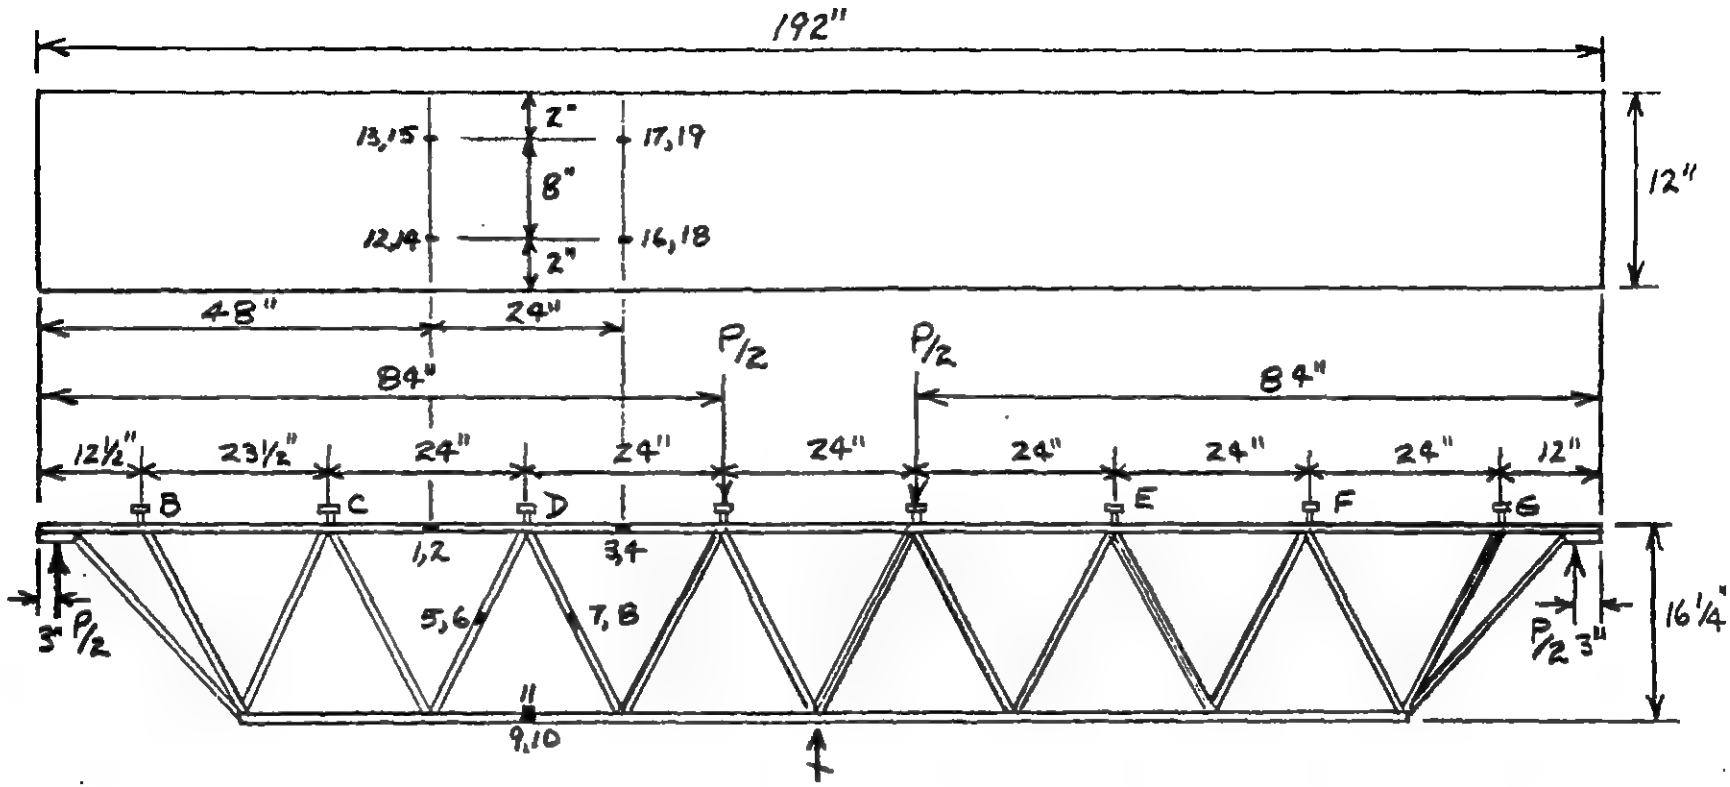
FIG 3m Test Joist B5

4.2.5 B5 - The load was applied in increments as observations were made. Cracks developed in the slab at the first shear connector in each span. After another two load increments cracks had also developed at the load point and the previous two had extended further into the slab. With additional loading it became a little difficult to hold the load steady. As the load was increasing the second weld connection of the right span between the web member and bottom chord fractured.

The failure of this beam was a result of the weld failure of the web member to the tension chord.

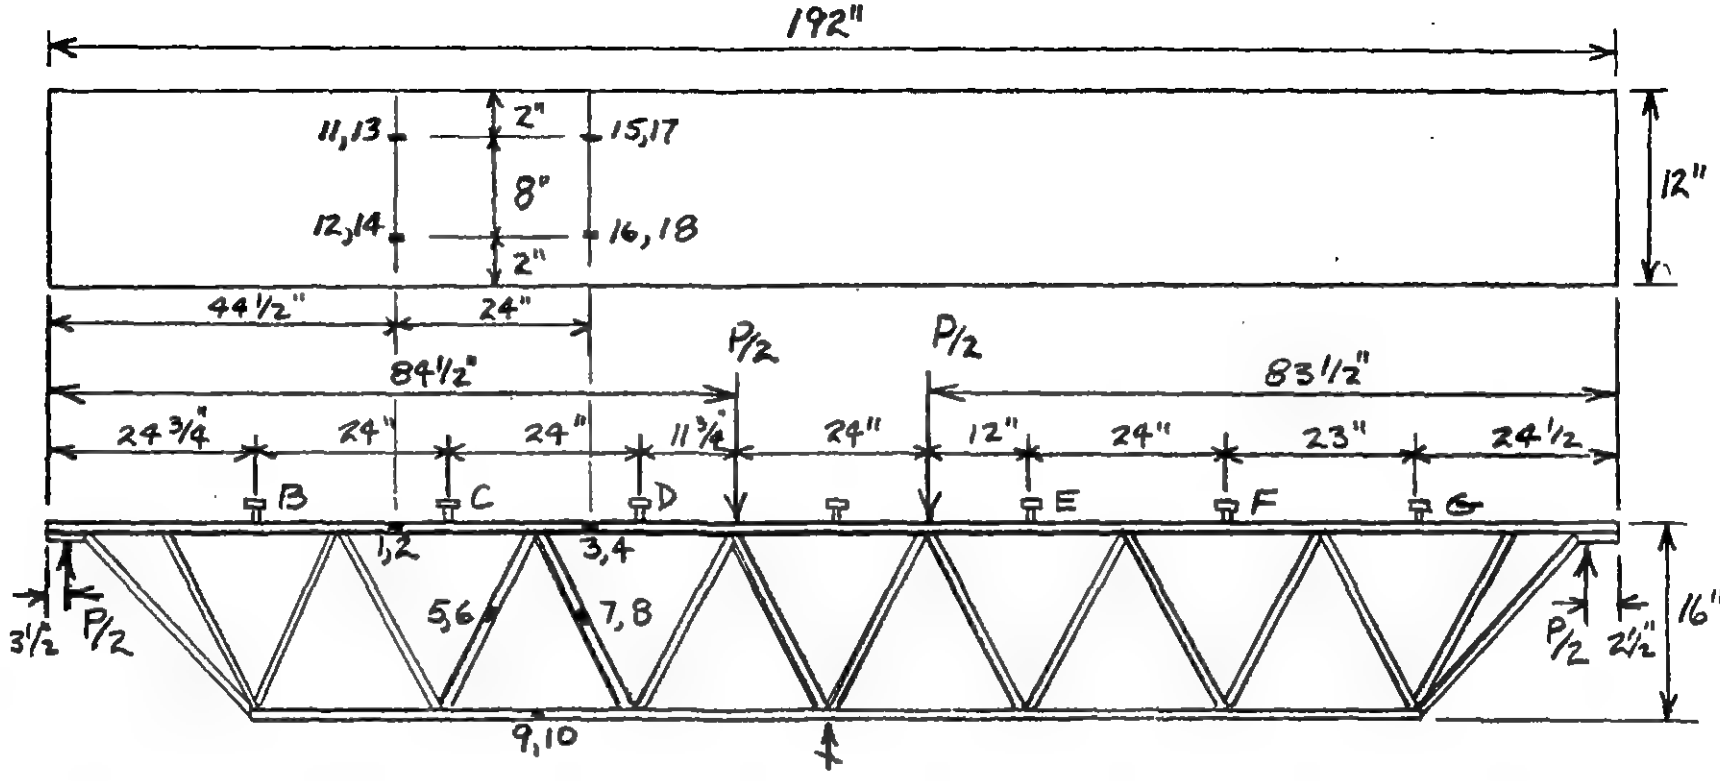
FIG 3n Test Joist B6

4.2.6 _B6 - After several load increments a crack appeared at the first shear connector of the right span. With additional loading the compression chord began to separate from the slab and cracks appeared at the third shear connector in each span. After additional loading a crack appeared at the left load point. The next loading resulted in the fracture of a weld between web and the tension chord. The beam was unloaded and the weld repaired.

The beam was incrementally loaded to its previous value and the test continued. Shortly thereafter it appeared as if the tension chord had yielded as large deflections with small load increases were obtained. As more load was applied it was noticed that the concrete slab was being bent in the reverse direction as tension cracks were appearing on the top of the slab. As more deflection occurred the slab split just to the left of the left load point.

Failure was attributed to yielding of the tension chord followed by the splitting of the concrete.

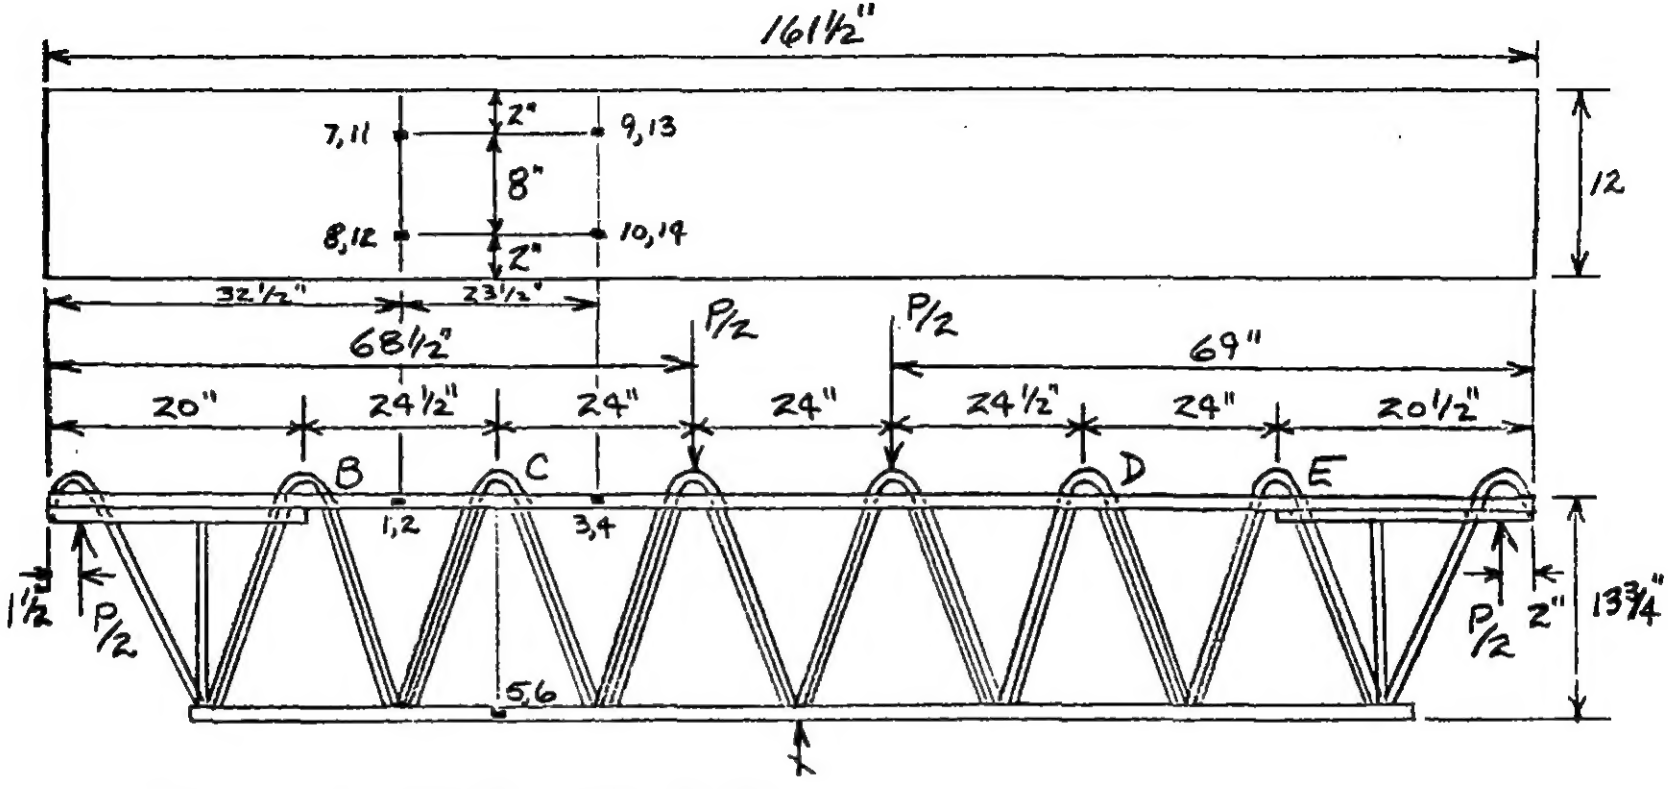
FIG 30 Test Joist B7

4.2.7 _B7 - The load was applied in increments as observations were made. Cracks appeared around the third extended web of the left span and the compression chord separated from the slab between this point and the left load point. As more load was applied the cracks and separation increased. A loud report was heard but no evident damage could be seen. With more loading the one compression member at the third extended web began to separate considerably indicating the weld at this point had fractured. The loading then became difficult to hold steady as the separation and concrete cracks increased. The concrete cracks around the third extended web developed into general crushing. With a loud report the extended web pulled out of the concrete and the compression chord

buckled.

Failure was attributed to crushing of the concrete followed by the buckling of the compression chord.
